DEPARTMENT OF TRANSPORTATION

Contract #: 04-0120F4Cty: SF/ALA Rte: 80 PM: 13.2/13.9File #: 69.28**WELDING INSPECTION REPORT****Resident Engineer:**Siegenthaler, Peter**Address:** 333 Burma Road**City:** Oakland, CA 94607**Report No:** WIR-020733**Date Inspected:** 18-Feb-2011**Project Name:** SAS Superstructure**OSM Arrival Time:** 700**Prime Contractor:** American Bridge/Fluor Enterprises, a JV**OSM Departure Time:** 1900**Contractor:** Zhenhua Port Machinery Company, Ltd (ZPMC), Changxing Island **Location:** Shanghai, China**CWI Name:** Li Yang and Zhu Zhong Hai**CWI Present:** Yes No**Inspected CWI report:** Yes No N/A**Rod Oven in Use:** Yes No N/A**Electrode to specification:** Yes No N/A**Weld Procedures Followed:** Yes No N/A**Qualified Welders:** Yes No N/A**Verified Joint Fit-up:** Yes No N/A**Approved Drawings:** Yes No N/A**Approved WPS:** Yes No N/A**Delayed / Cancelled:** Yes No N/A**Bridge No:** 34-0006**Component:** OBG Trial Assembly**Summary of Items Observed:**

Orthotropic Box Girder (OBG) at Trial Assembly Areas

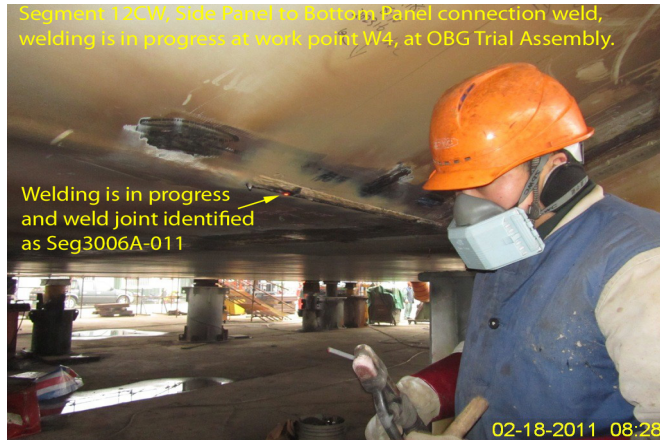
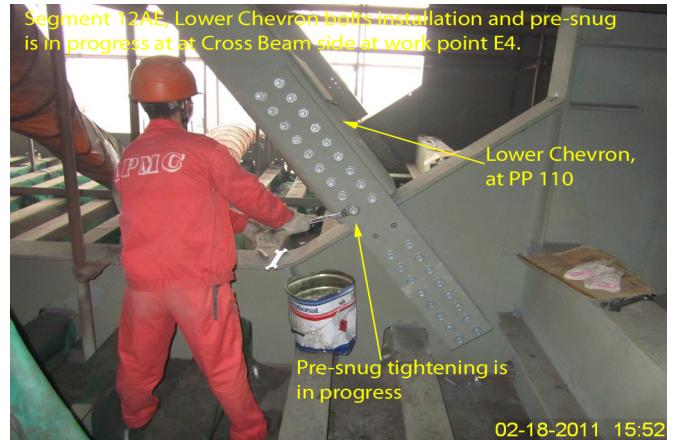
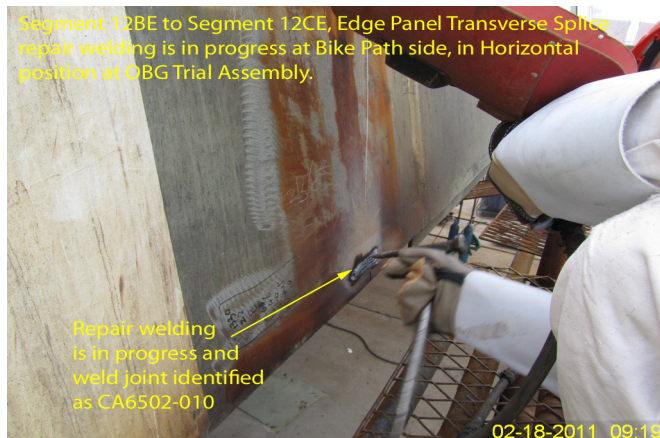
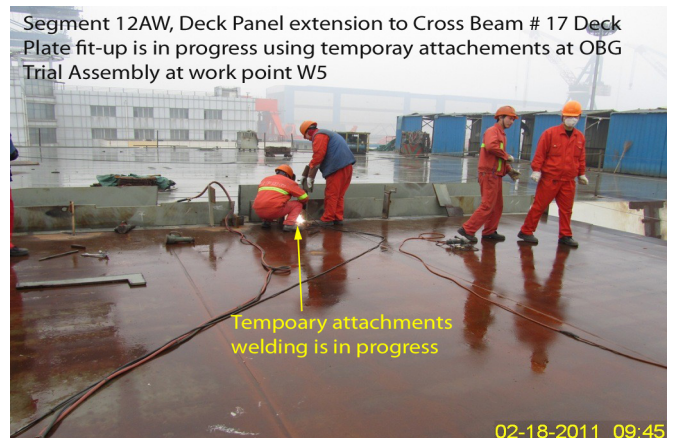
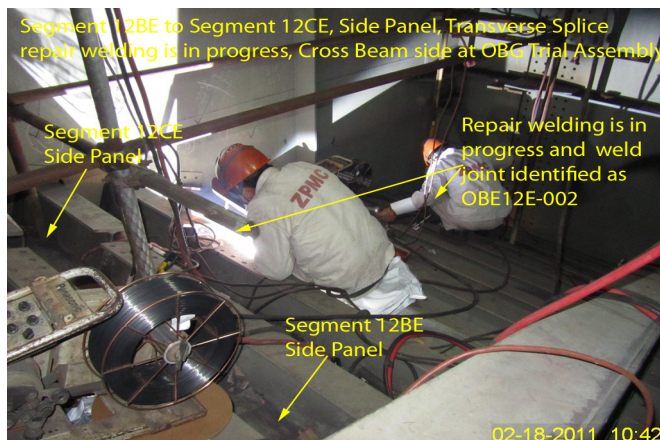
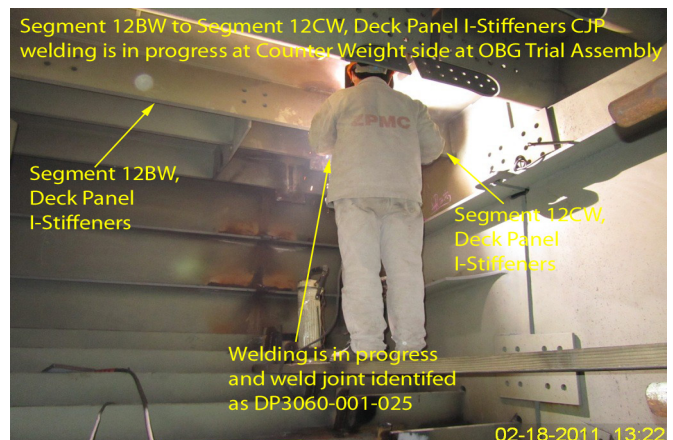
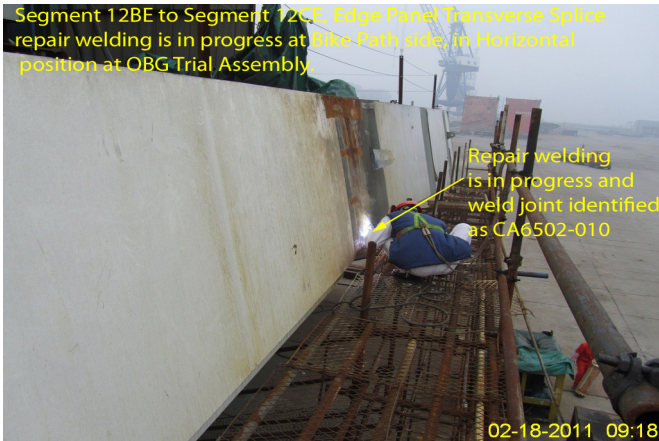
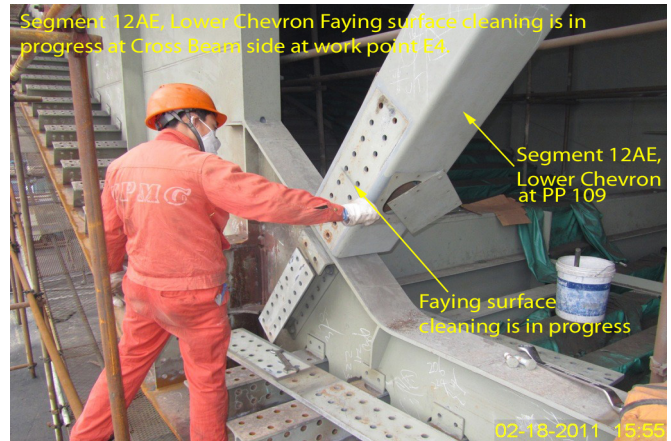
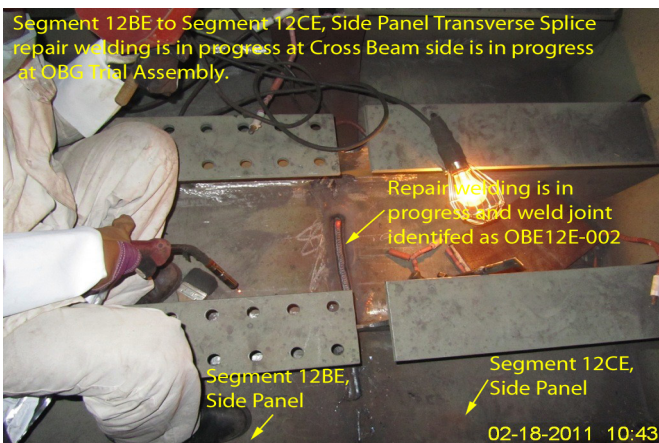
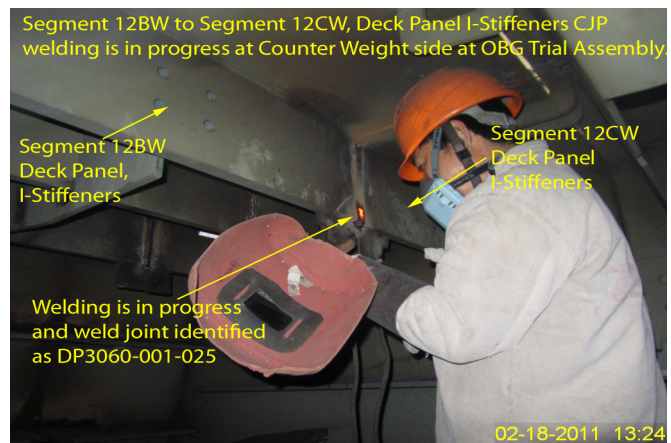
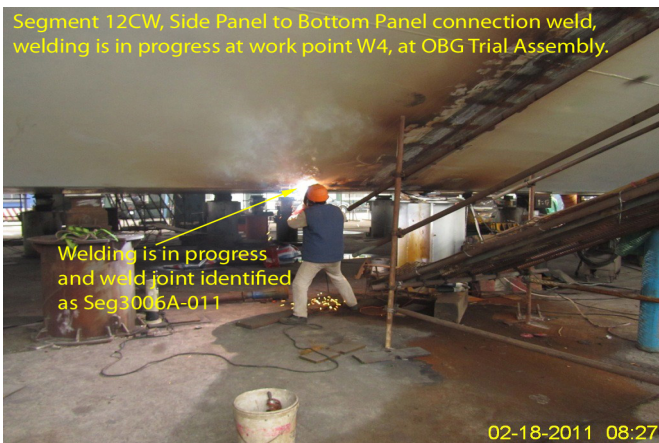
Please reference the pictures attached for more comprehensive details.

This QA Inspector observed the in-process welding by Shielded Metal Arc Welding (SMAW) process on a Complete Joint Penetration (CJP) groove weld. The Weld joint was designated as Seg3006A-011. The welder identification was 057333 and was observed welding in the 4G (Overhead) position using approved Welding Procedure Specification WPS-B-P-2214-B-U2-FCM-1. The piece mark was identified as weld connecting Bottom Panel to Side Panel hold back weld at work point W4.

Please reference the pictures attached for more comprehensive details.

This QA Inspector observed the repair welding by Flux Cored Arc Welding (FCAW) process on a Complete Joint Penetration (CJP) groove weld. The Weld joint was designated as OBE12E-002. The welder identification was 040367 and 052763 and observed welding in the 3G (Vertical) position using approved Welding Procedure Specification WPS-345-FCAW-3G(3F)-ESAB-1. The piece mark was identified as the Side Panel Cross Beam side, at transverse splice. ZPMC performed repair welding in accordance with Welding Repair Report B-WR20176.

This QA Inspector observed the repair welding by Shielded Metal Arc Welding (SMAW) process on a Complete Joint Penetration (CJP) groove weld. The Weld joint was designated as OBE12E-002. The welder identification was 044515 and observed welding in the 4G (Overhead) position using approved Welding Procedure Specification WPS-345-SMAW-4G(4F)-FCM-Repair-1. The piece mark was identified as the Side Panel, Cross Beam side, at transverse splice. ZPMC performed repair welding in accordance with Welding Repair Report B-WR20176.

This QA Inspector observed the repair welding by Shielded Metal Arc Welding (SMAW) process on a Complete Joint Penetration (CJP) groove weld. The Weld joint was designated as CA3005-002. The welder identification was 052493 and observed welding in the 4G (Overhead) position using approved Welding Procedure Specification WPS-345-SMAW-4G(4F)-FCM-Repair-1. The piece mark was identified as the weld connecting the Deck Panel to the Edge Panel, Bike Path side. ZPMC performed repair welding in accordance with Welding Repair Report B-WR20195.

This QA Inspector observed the repair welding by Shielded Metal Arc Welding (SMAW) process on a Complete Joint Penetration (CJP) groove weld. The Weld joint was designated as CA3005-001. The welder identification was 052493 and observed welding in the 4G (Overhead) position using approved Welding Procedure Specification WPS-345-SMAW-4G(4F)-FCM-Repair-1. The piece mark was identified as the weld connecting the Side Panel to the Edge Panel, Bike Path side. ZPMC performed repair welding in accordance with Welding Repair Report B-WR20202.

This QA Inspector observed the in-process welding by Shielded Metal Arc Welding (SMAW) process on a Complete Joint Penetration (CJP) groove weld. The Weld joint was designated as DP3060-001-025. The welder identification was 041713 and observed welding in the 3G (Vertical) position using approved Welding Procedure Specification WPS-B-T-3213-B-U3b-FCM-1. The piece mark was identified as the Deck Panel, I-Rib splice at Counter Weight side.

This QA Inspector observed ZPMC personnel welding the temporary attachments for the Deck Panel extension at Segment 12AW to the Cross Beam # 17 between PP 110 to PP 111 and PP 111 to PP 112 for fit-up purpose. The welder was identified as 205616.

This QA Inspector observed ZPMC personnel performing bolts installation and pre-sung tightening for the bolts installed at Lower Chevron for Segment 12AE at PP 110 at work point E4.

This QA Inspector observed ZPMC personnel removed the east and west side of splice plates of the Lower Chevron and observed faying surface cleaning is in progress for Segment 12AE at PP 109 at Cross Beam side.
